**NJS Presents*****Museums, Archives, Artifacts, and Documents*****In This Issue:*****The 1926 Lake Denmark Explosion:******An Extraordinary Mishap That Changed Military Safety Standards*****By Rachael Winston****DOI: <https://doi.org/10.14713/njs.v7i1.230>**

*Prior to 1926, the American Table of Distances did not adequately take into consideration the potential for munition storage facilities to exceed capacities. This study aims to provide an overview of the construction and use of munition storage facilities and examine how the American Table of Distances would dramatically change due to the 1926 explosion at the Lake Denmark Naval Ammunitions Depot. The historical literature examining the correlation between the American Table of Distances and storage capacities is limited, and independent inquiries by the United States Government and first-person accounts of the explosion exist. However, these sources had not been collectively assembled into a study to provide historical context. From this research, it can be determined that it was only a matter of “when” would a disaster strike, as storage facilities up and down the eastern seaboard were experiencing exceeded capacities. Thi

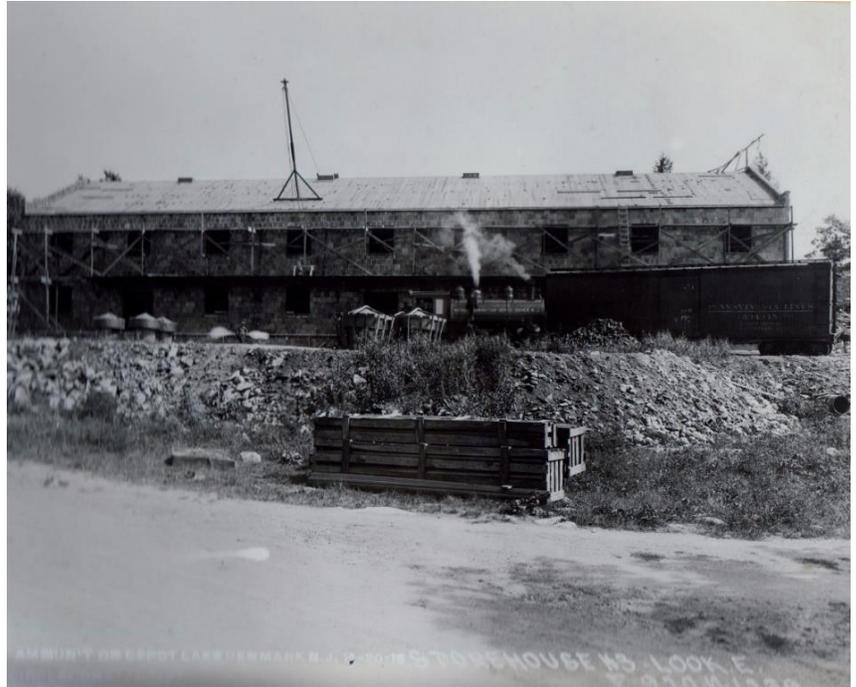
*Storehouse No 3, from the collection of the National Archives at New York City.*

Finally, long warehouse buildings referred to as “Austin Buildings” were constructed as storehouses with “concrete foundations, 9in. hollow clay tile walls with plasters under the trusses, steel trusses or girders, steel rafters sheathed with roof boards and paper roofing.”<sup>10</sup> According to the Austin Co. website, the company was started in Cleveland, Ohio in 1878 by Samuel Austin. By 1904, Samuel’s son, Wilbert J. Austin, joined his father’s company and conceived the then heretical idea of combining engineering and construction in one firm to offer a complete facility service. This concept, which became known as The Austin Method®, broadened the traditional approach to construction by offering contracts that started with architecture and engineering, and ended with the finished building.<sup>11</sup>

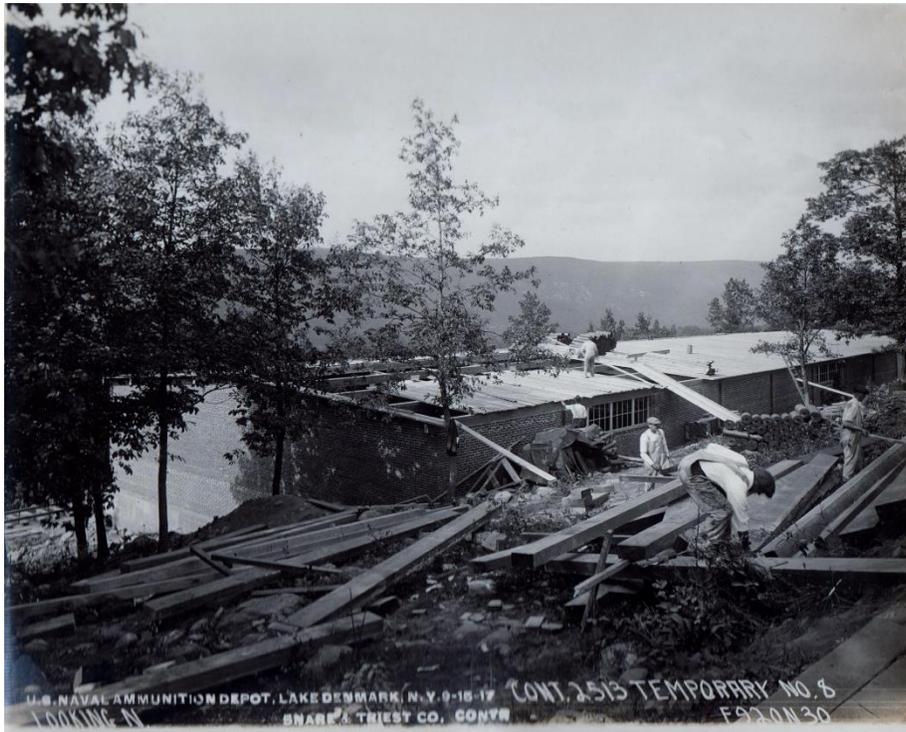
*Construction of Temporary Magazine Number 8 during 1917, from the collection of the National Archives at New York City.*

Many temporary ammunition storage buildings were constructed as a long, one-story above-ground structures made from hollow clay tiles that were used to store powder, shells, or fixed-ammunition. These buildings were moderately standard with the height of the building approximately 14 feet from ground level to their roof, which was steel-truss clad with asbestos shingles. Buildings had 10-foot bays, varied in length up to 250 feet long, and were located along railroad tracks for easy loading and unloading on to concrete platforms, each were surrounded by lightning protection poles with appropriate fire protection services nearby.<sup>8</sup>

Temporary Magazine Number 8 was a typical, aboveground, 150-by-200-foot clay tile, storage structure overloaded with leftover ordnance. After about ten minutes from the first report of a fire, only a crater remained where the magazine once stood. Missiles could be found up to a mile away, while fifteen miles away in Pompton Lakes embers and ash were reported by

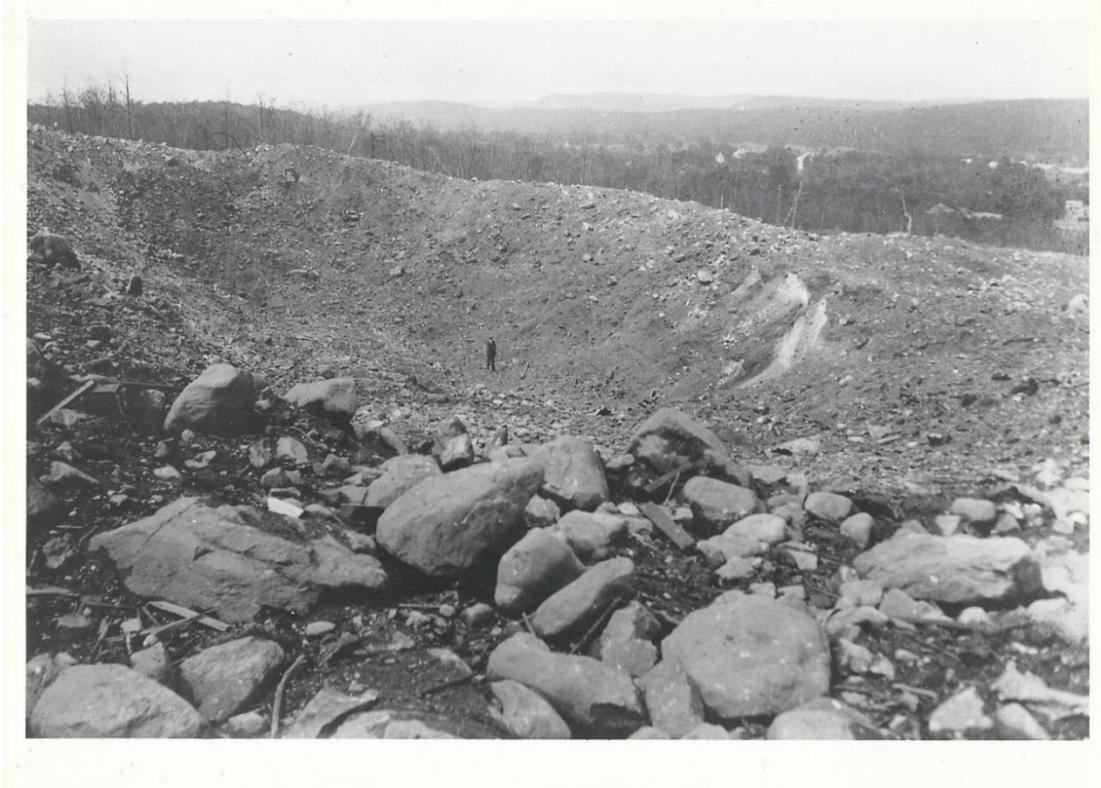
**A large crater where Temporary Magazine 8 once stood, from the collection of U.S. Army Combat Capabilities Development Command (DEVCOM) Armaments Center Historian Jeff Ranu.**

The direct effect of the blasts caused the complete and total annihilation of structures within a radius of 2,700 feet and damaged buildings up to 8,700 feet away. Nineteen people died, mostly Marines, while fighting the various fires. Over 50 more were injured from the blasts. The damage

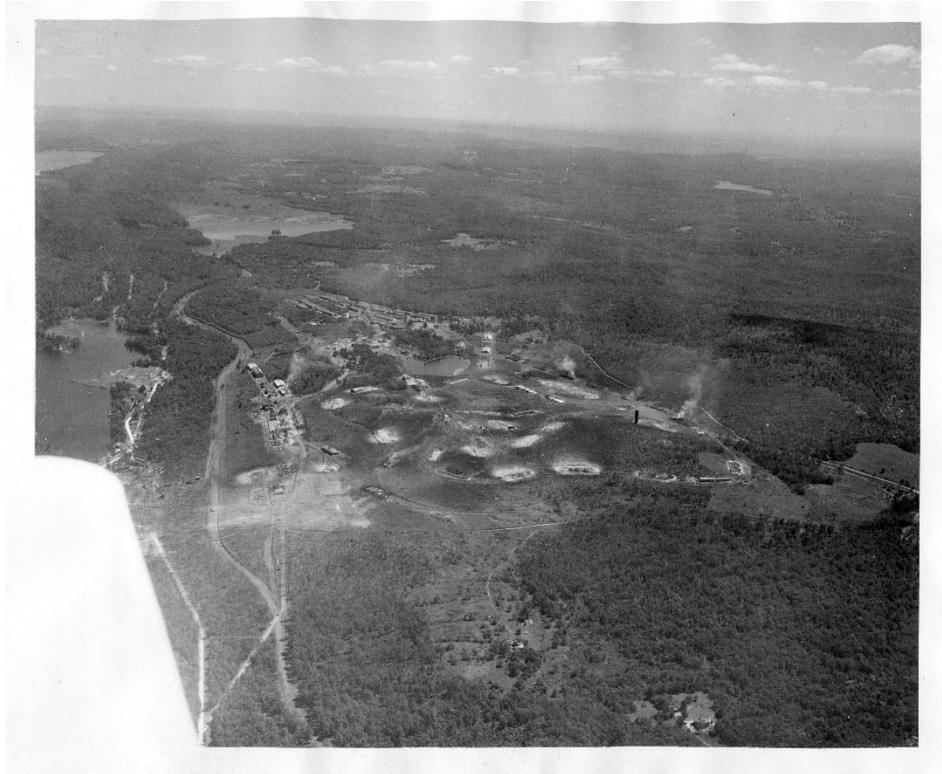
**Flyover of Lake Denmark after the explosion, from the collection of DEVCOM Armaments Center Historian Jeff Ranu.**

to munitions and other stores exceeded \$40,000,000.<sup>15</sup> These intense explosions and fires also devastated the adjoining Picatinny Arsenal and caused major damage to most of the buildings.<sup>16</sup> While Picatinny Arsenal did have ammunition stores buildings, the bulk of the damage came from the three large explosions due to items stored at Lake Denmark NAD detonating.
